Service Letter SL 32 - Revision 5	DOA - No. EASA.21J.020
--	--	---------------------------

Affected Propellers

All MT-; MTE- and MTV- Propellers with Natural Composite Blades!

During the operation time between overhaul periods it is sometimes necessary to perform minor field repairs of the natural composite MT-Propeller blades. This Service Letter defines limitations of maximum dimensions of damage which are repairable in field and serves as a guideline how to perform such repairs.

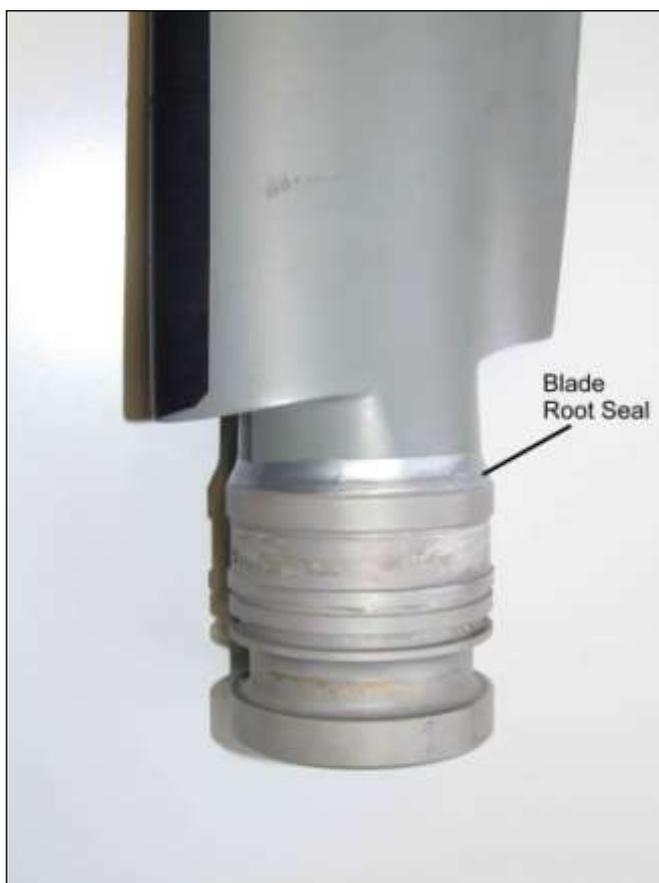
Possible Damage: Cuts due to incorrect spinner installation.

Repair: Clean the affected area and fill up the affected area with Silicone.
(Refer to List of Materials)

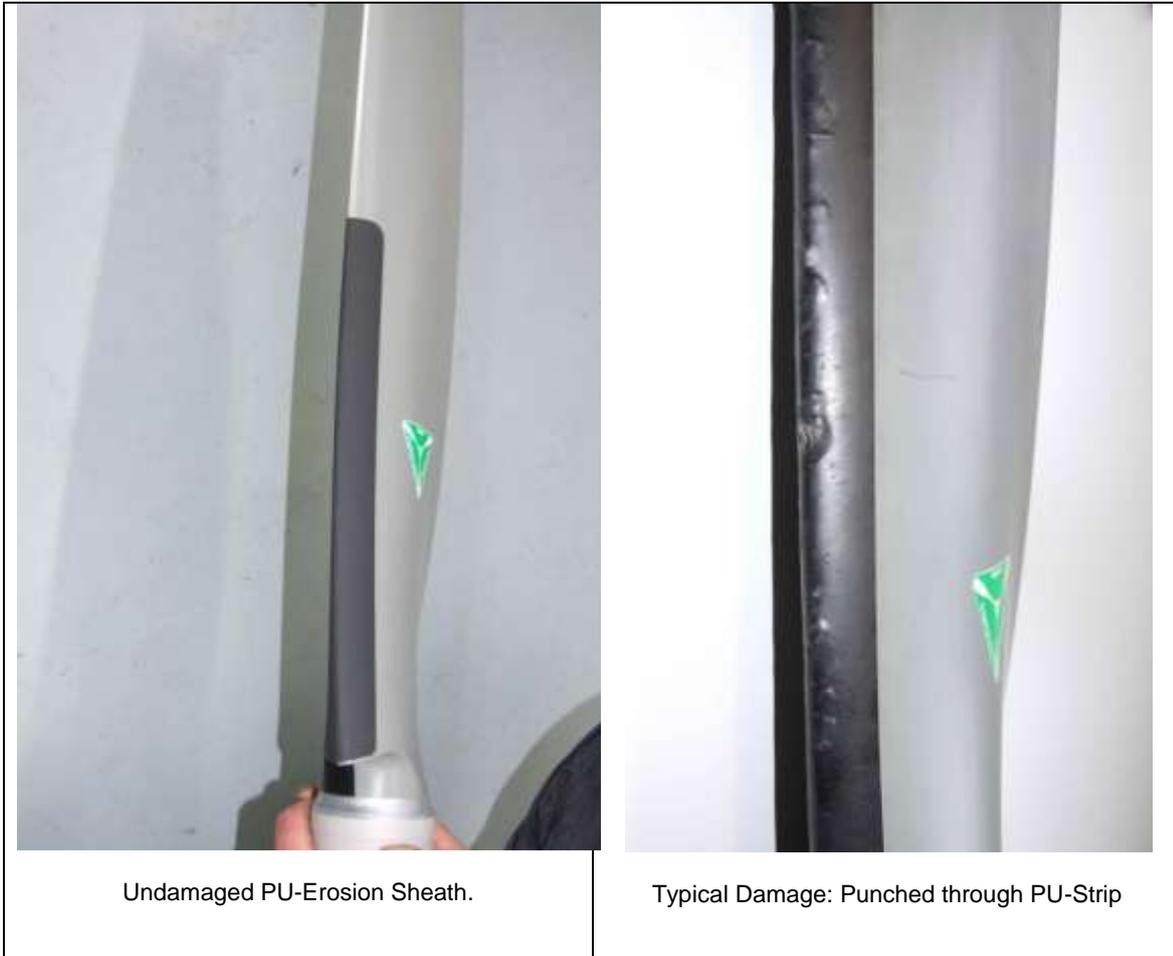
Possible Damage: Punched through or missing.

Repair: Completely replace erosion strip according to SI.37 ()

The PU-strip must be installed at the leading edge of the propeller starting from the silicone on the blade ferrule, ending 50 mm (2.0 in) beyond the metal leading edge.

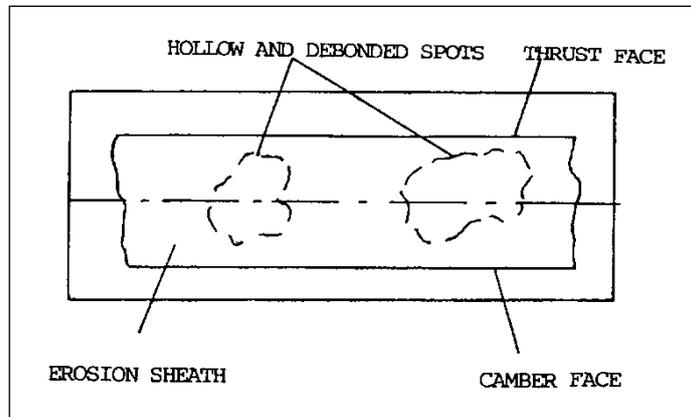
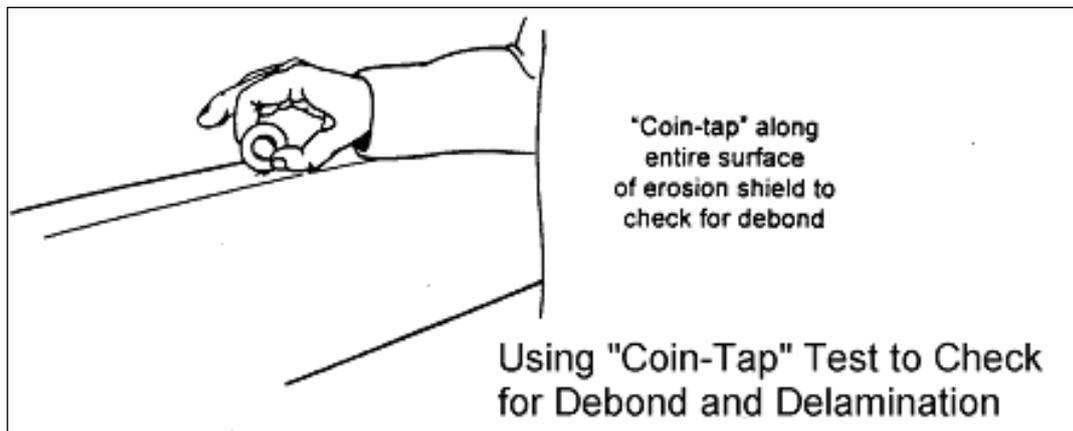
In case of debonding only very limited repair is possible. However, the extent of debonding where repair is required is defined and not every debonding requires repair.

- If any hollow and debonded spots exist, mark them.
- Whenever performing pre-flight inspection, monitor whether there are further delamination and/or whether the already existing delamination has become worse.
- The inspection can be executed by using an appropriate coin (Tab-Test).

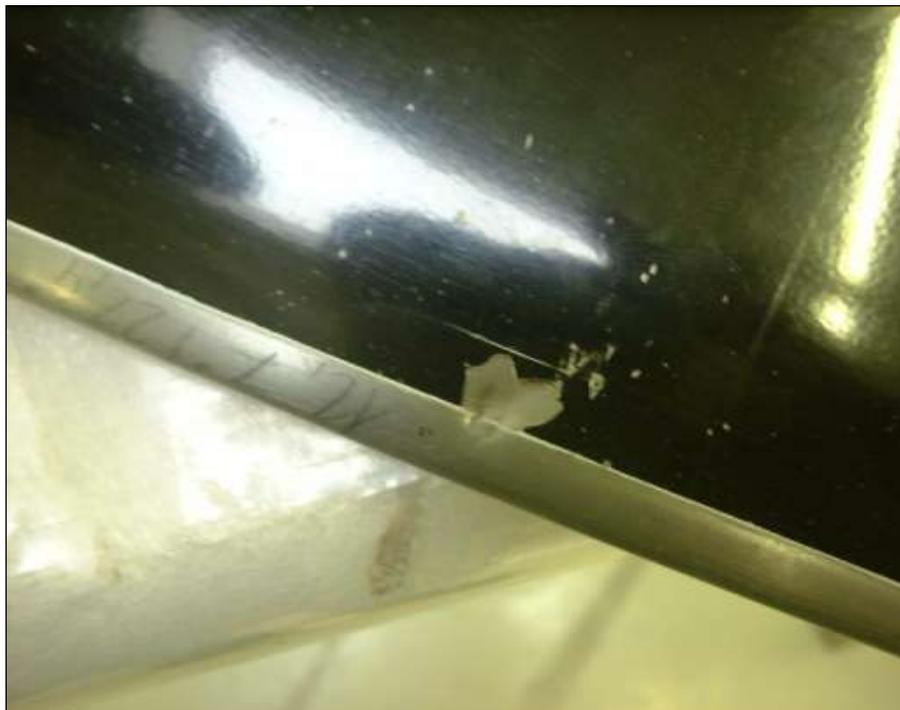
- ✓ The hollow and debonded spots must not exceed 30% of the surface of the erosion sheath at all (lengthwise only 25 mm (1.0 in) are allowed).
- ✓ Hollow and debonded spots (max. 0.39 square in* / 2.5cm²), no two spots may occur within 130 mm (5.0 in) of each other.
- ✓ Debonded areas which result in an open bonding crack must be sealed in order to prevent water from penetrating.
- ✓ The length of open bonding cracks must not exceed 25 mm (1.0 in)!

- ✓ Bonding cracks which are not open to the blade tip may be resealed by using 5-Minute Epoxy.

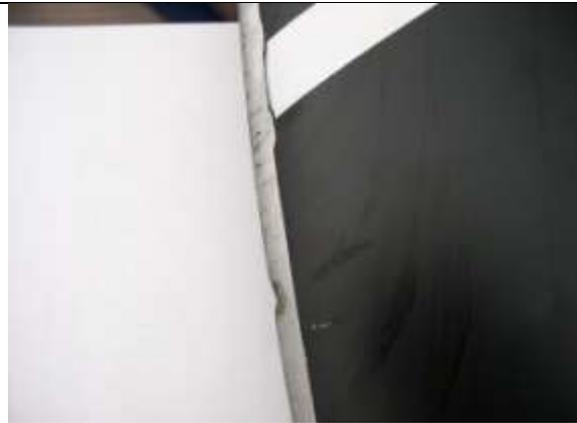
FOD below 6 mm x 6 mm (0.24 in x 0.24 in):

If within 51 mm (2 in) no other dents of that size are visible, the dent size may exceed the original maximum size by 3 mm (0.12 in) to a maximum of 9 mm x 9 mm (0.36 in x 0.36 in).

If within 76 mm (3.0 in) no other dents of that size are visible, the dent size may exceed original maximum size by 5 mm (0.197 in) to a maximum of 11 mm x 11 mm (0.43 in x 0.43 in)

No action necessary if not delaminated.

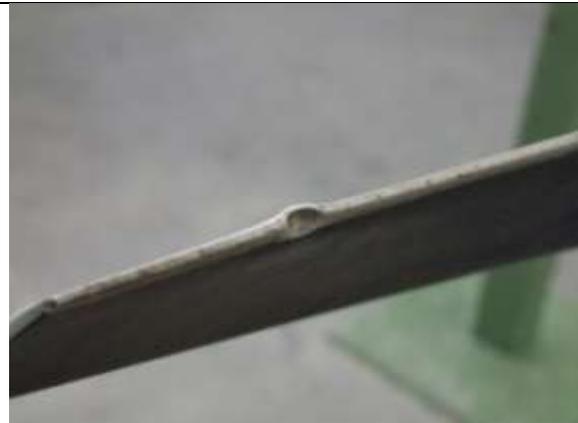
FOD exceeding limits.

Limits are determined on the left side.

Replace Erosion Sheath as soon as possible!

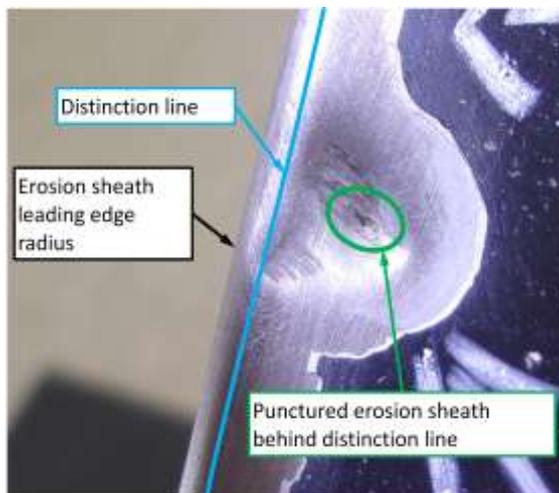
Damaged area can be filled with epoxy; erosion sheath will be replaced at next overhaul

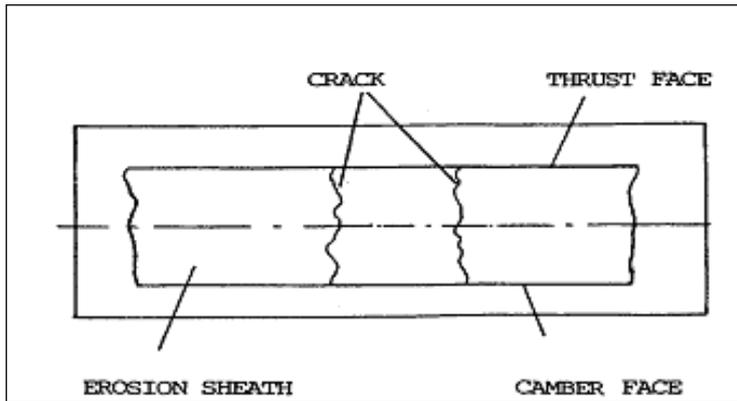
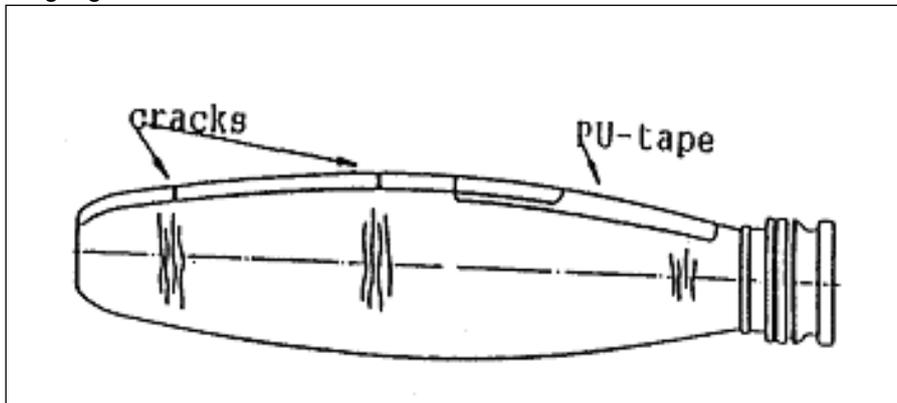
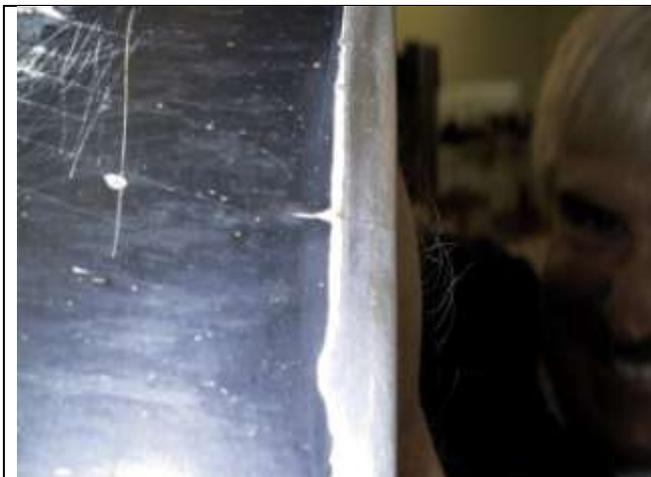
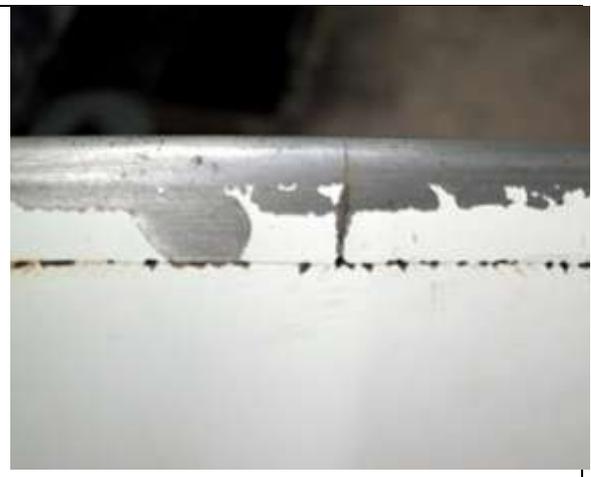
Chord wise cracks in the erosion sheath may also occur together with fine surface cracks indicating high vibration loads on the blade.

When Erosion Sheath is cracked chord wise no field repair is possible

Cracked erosion sheaths require immediate repair. If chord wise cracks appear, return the propeller to the manufacturer or any authorized Service station.

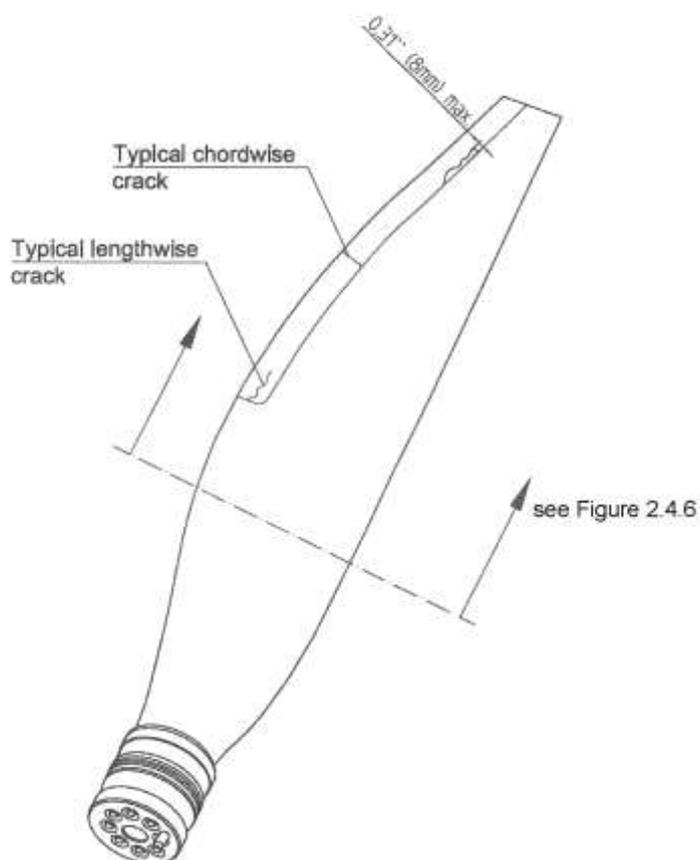
Airworthy damage limits: Two chordwise cracks are only allowed if they are not starting from the camber side to the thrust side and may not be within 152.5mm (6 in) of each other. A chordwise crack over 25 mm (1.0 in) may not be within 152 mm (6.0 in) of the blade tip. A chordwise crack over 25 mm (1.0 in) may not be within 152 mm (6.0 in) of the outboard end of the anti-icing boot. A chordwise crack over 25.5 mm (6 in) may not be within 152 mm (6.0 in) of the inboard end of the erosion shield (when not covered by anti-icing boot). Refer to Fig.1, 2

Airworthy damage limits: The maximum permitted length of a crack is 50 mm (2.0 in). Two lengthwise cracks may not be within the same linear length on the erosion shield. This includes cracks on opposite sides of the blade. Refer to figure 1, 2, 4, 5.

Figure 1: Missing portions of Nickel erosion shield (Trail side) and typical cracks

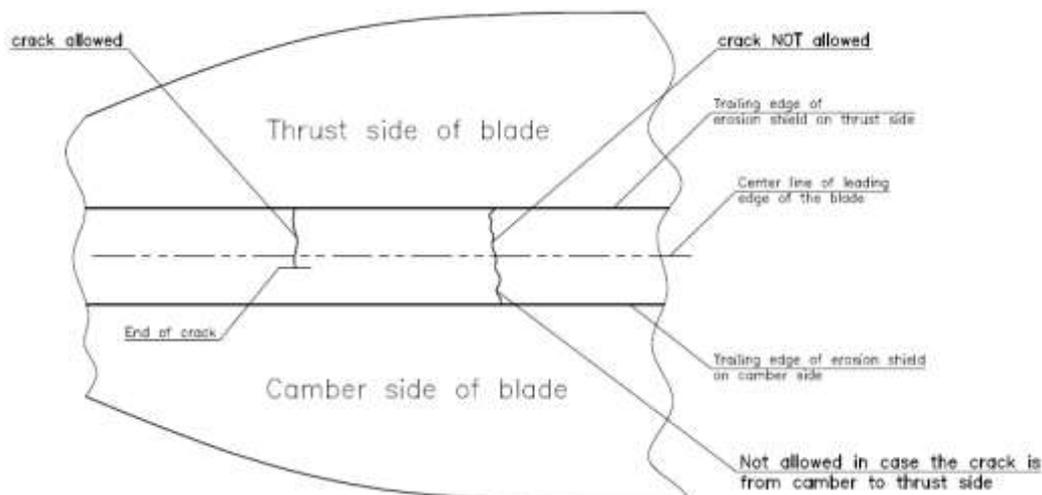
Figure 2: Interpretation of Erosion Shield Damage

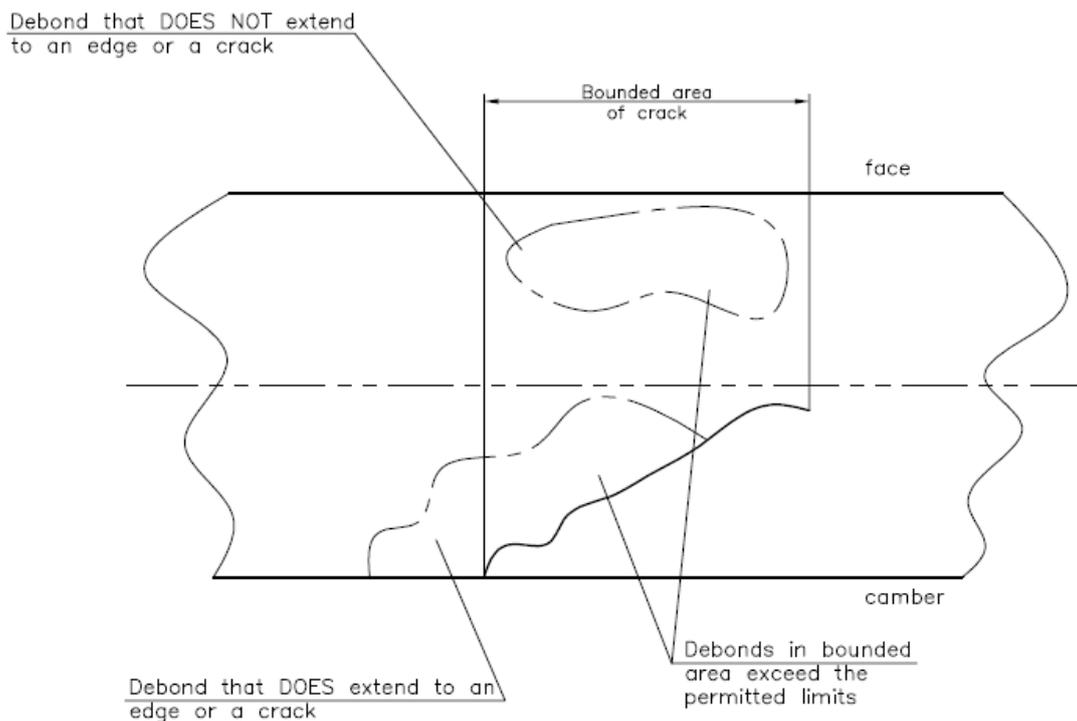
Airworthy damage limits: A maximum of 20 % of the erosion shield may be debonded in any 152 mm (6.0 in) length of the erosion shield
Refer to Figure 1, 3

Fig.3 Debonds in excess of allowable limits

Major repair limits: Major repair is not allowed. If the debond is greater than the airworthy damage limits and cannot be repaired under Minor Repair, an overhaul is required including leading edge replacement.

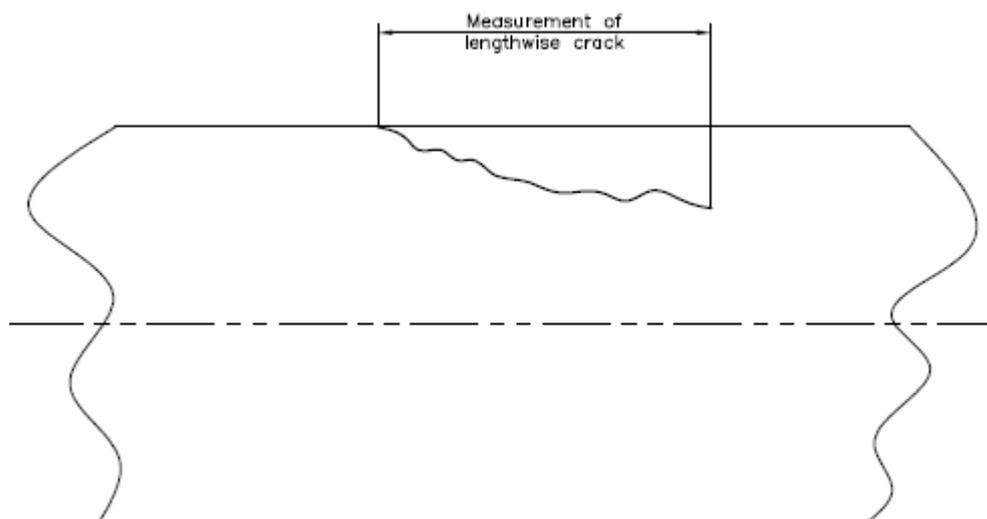
Figure 4: Measuring lengthwise crack

In any case, seal the crack with any 5-Minute Metal Epoxy or similar to avoid moisture entering below the leading edge.

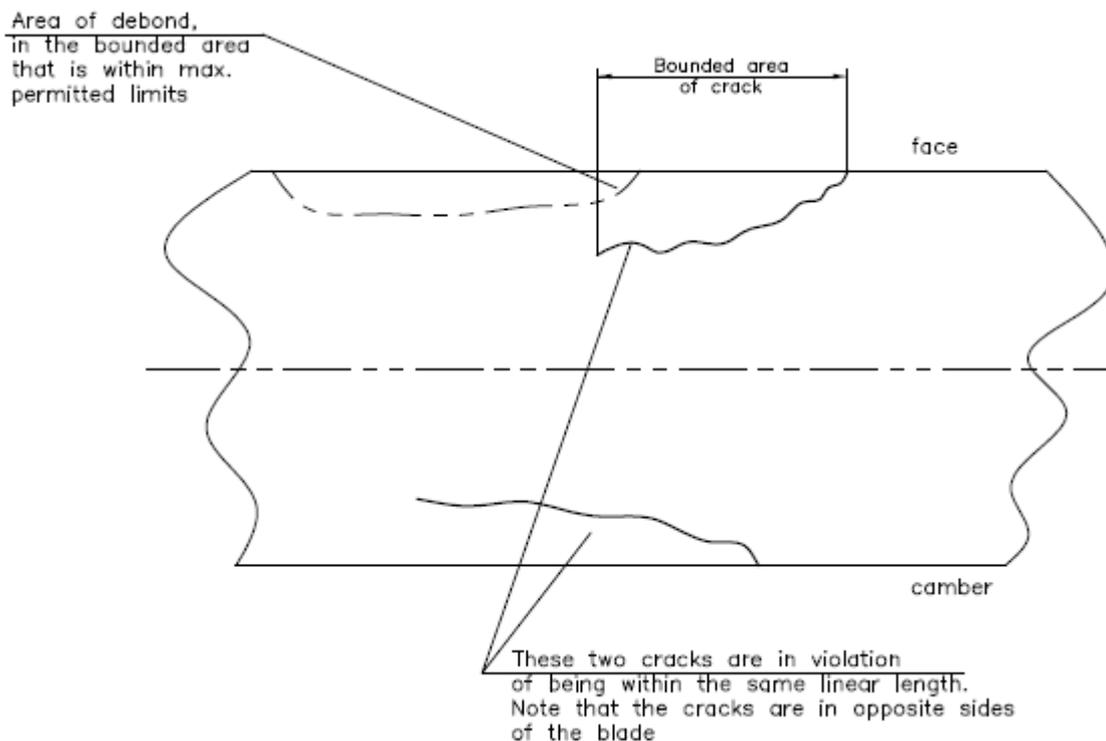
Figure 5: Acceptable Erosion Shield Debond, non acceptable crack location

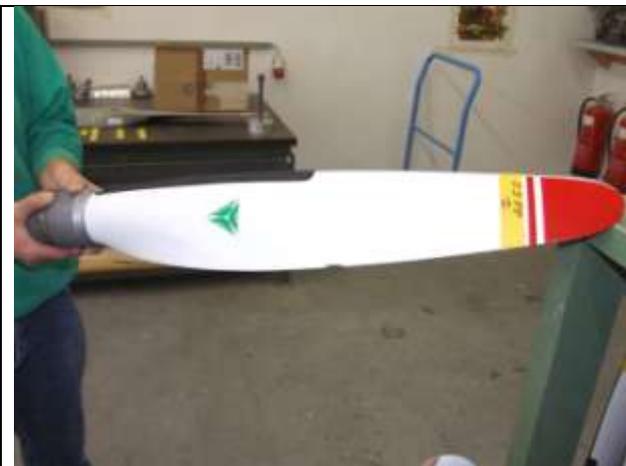
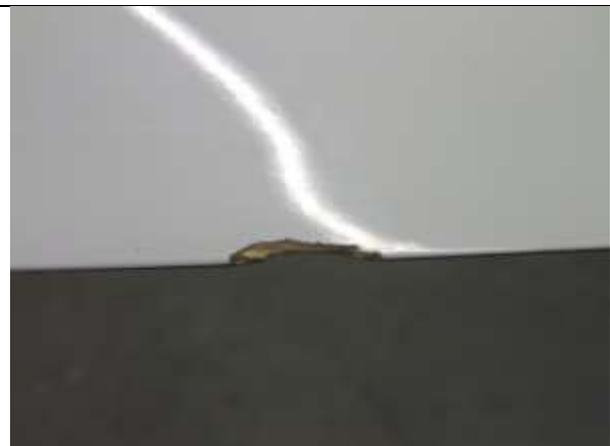
Tow bar damage, seal with Epoxy or repair permanently with fiber glass

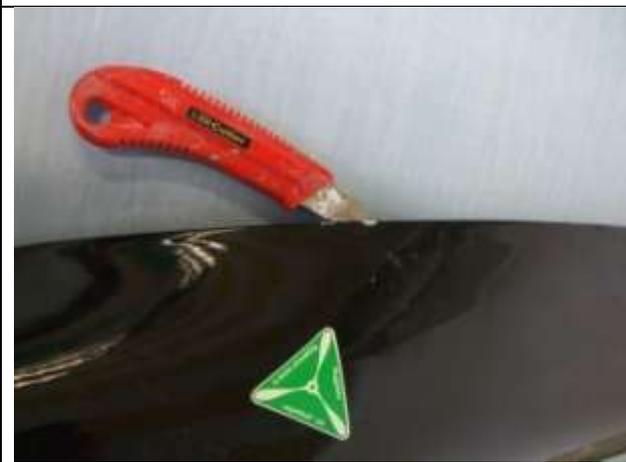
Delaminated composite shell on the trailing edge

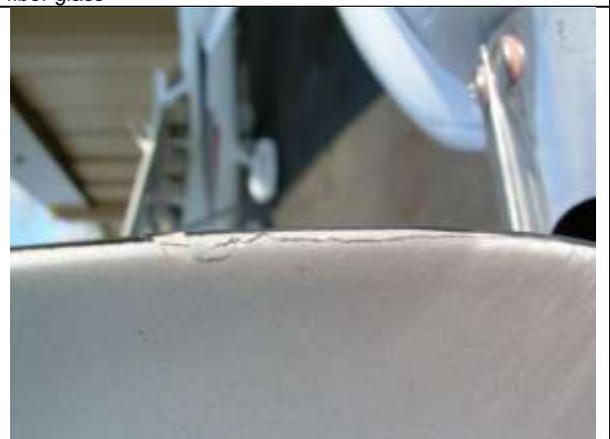
Damage caused by Cowling, seal and fill up with Epoxy

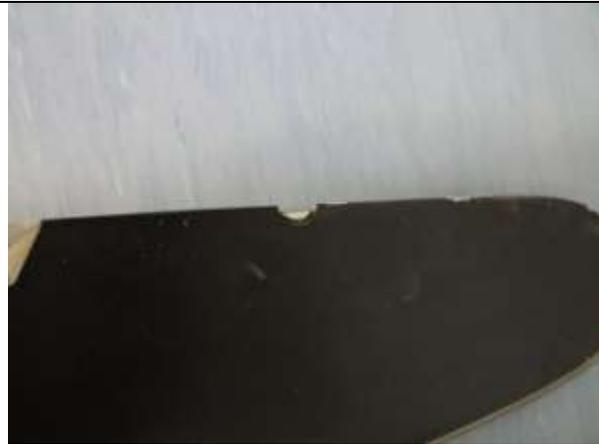
Minor damage on the trailing edges may be sealed with 5-Minute Epoxy

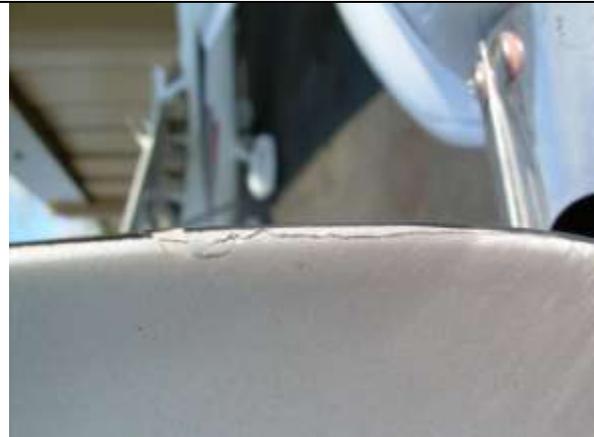
Longitudinal cracks may be sealed with 5-Minute Epoxy

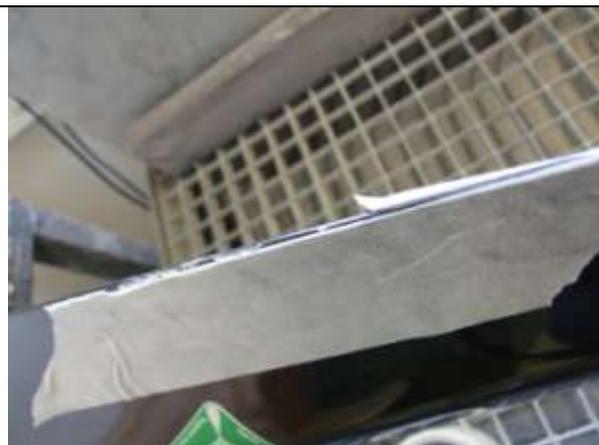
If the fiberglass shell on the trailing edge is delaminated the shell may be rebonded.
Let pour 5 minute Epoxy into the trailing edge crack.

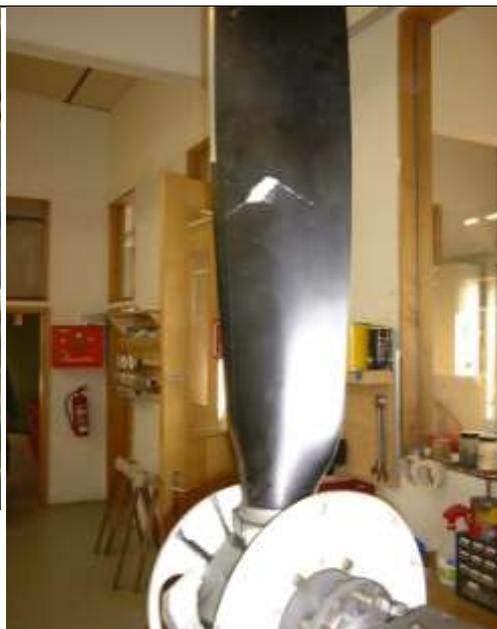
Blade surface damage obviously exceeding the field repair limits

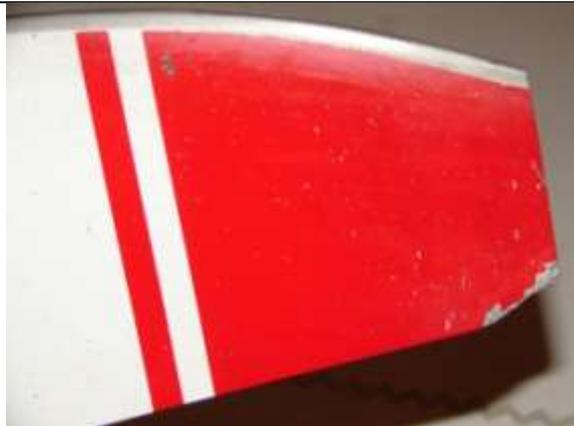
<p>Hangar Damage: Broken Tip Trailing Edge Seal with 5 Minute Epoxy or permanent repair with Fiber Glass.</p>

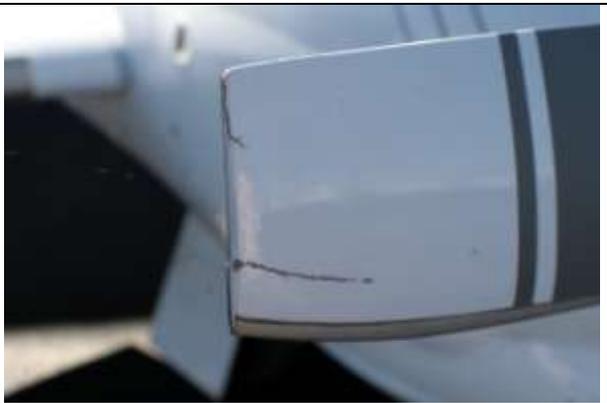
<p>Split Blade Tip and delaminated trailing Edge. Rebond Trailing Edge with 5 Minute Epoxy. Repair split Tip with Fiber Glass</p>
