Service Letter SL 32 - Revision 5	DOA - No. EASA.21J.020
--	--	---------------------------

Affected Propellers

All MT-; MTE- and MTV- Propellers with Natural Composite Blades!

During the operation time between overhaul periods it is sometimes necessary to perform minor field repairs of the natural composite MT-Propeller blades. This Service Letter defines limitations of maximum dimensions of damage which are repairable in field and serves as a guideline how to perform such repairs.

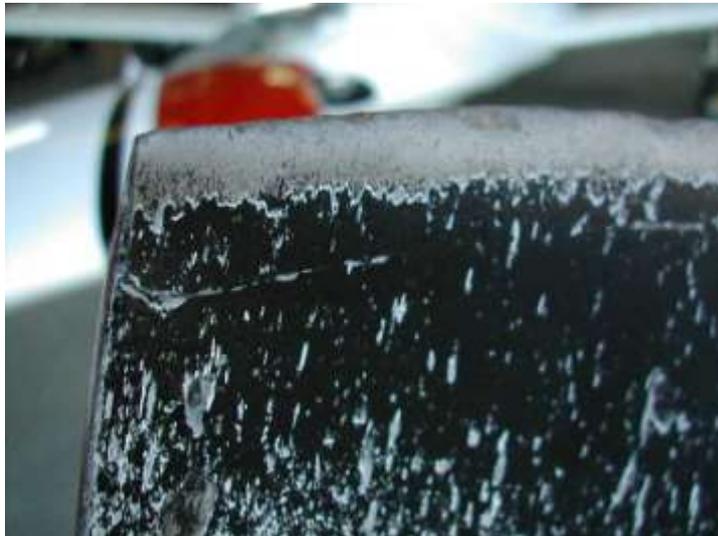
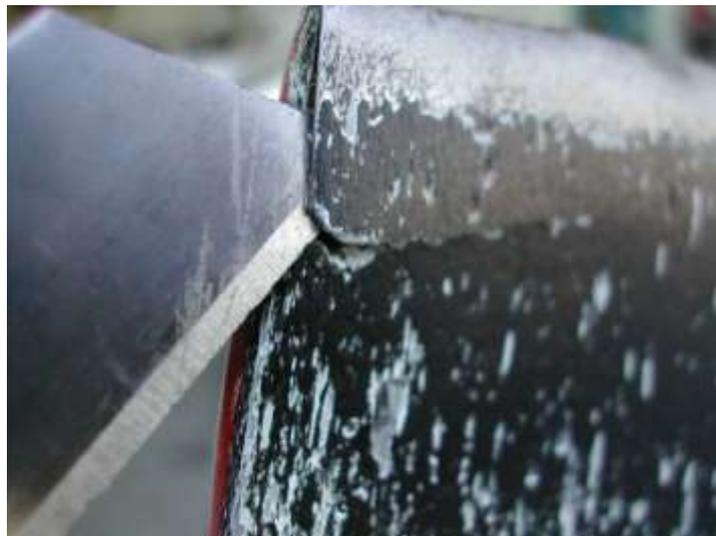
- ✓ The hollow and debonded spots must not exceed 30% of the surface of the erosion sheath at all (lengthwise only 25 mm (1.0 in) are allowed).
- ✓ Hollow and debonded spots (max. 0.39 square in* / 2.5cm²), no two spots may occur within 130 mm (5.0 in) of each other.
- ✓ Debonded areas which result in an open bonding crack must be sealed in order to prevent water from penetrating.
- ✓ The length of open bonding cracks must not exceed 25 mm (1.0 in)!

- ✓ Bonding cracks which are not open to the blade tip may be resealed by using 5-Minute Epoxy.

- ✓ Bonding cracks which are open to the blade tip must be sealed using the original erosion sheath bonding epoxy. Refer to Table 1.
- ✓ Whenever performing pre-flight inspection, monitor whether there are further delamination and/or whether the already existing delamination becomes worse.
Check secure fixing of the erosion sheath in any case every time before flight.
- ✓ If any of the above listed limits is exceeded the blade is to be sent to the manufacturer or to an authorized Service Station for repair as soon as possible.

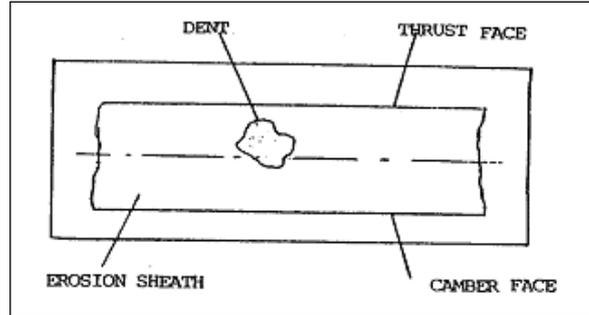
2.3.2. Erosion Sheath Dents due to FOD on stainless steel edge

- ✓ Circular dents not more than 0.24 in x 0.24 in (6 mm x 6 mm)
- ✓ Pointed dents not more than 0.24 in x 0.24 in (6 mm x 6 mm)
- ✓ If within 51 mm (2.0 in) no other dents of that size are visible, the dent size may exceed the original maximum size by 3 mm (0.12 in) to a maximum of 9 mm x 9 mm (0.36 in x 0.36 in).
- ✓ If within 76 mm (3.0 in) no other dents of that size are visible, the dent size may exceed the original maximum size by 5 mm (0.2 in) to a maximum of 11 mm x 11 mm (0.43 in x 0.43 in).

Replace Erosion Sheath as soon as possible!

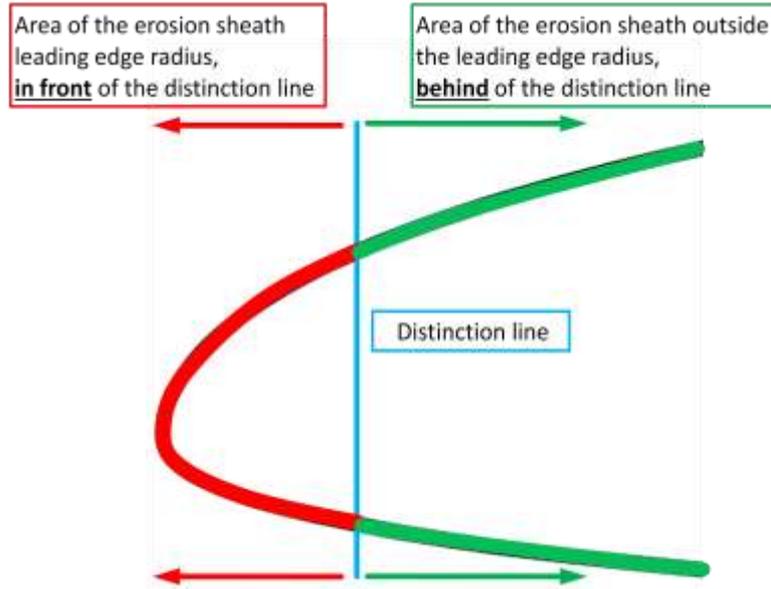
2.3.3. Punctured stainless steel erosion sheath due to FOD

The leading edge radius is most prone to moisture in operation; therefore it needs to be ensured that the natural composite core of the blade is protected against water intrusion. The distinction line is located behind the leading edge radius and determines how to handle a punctured erosion sheath.

Area where the erosion sheath has been punctured **in front of the distinction line**:

- Fill with epoxy to prevent moisture intrusion
- Monitor the area at pre-flight inspection
- Replace the erosion sheath as soon as possible

- Fill with epoxy to prevent moisture intrusion
- Erosion sheath is replaced at next overhaul
- Monitor the area at pre-flight inspection

Damaged area can be filled with epoxy; erosion sheath will be replaced at next overhaul

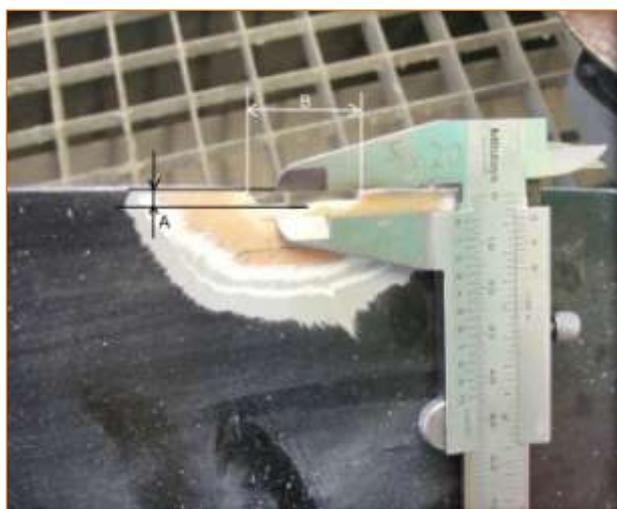
Crunched trailing edges can be sealed by using 5 minute Epoxy if the damage is not deeper (Dimension A) than 5 mm (0.20 in) and not wider (Dimension B) than 15 mm (0.60 in).

Crunched trailing edges can be repaired by replacing the fiber glass cover if the damage is not deeper (Dimension A) than 7.5 mm (0.30 in) and not wider (Dimension B) than 25 mm (1.0 in).

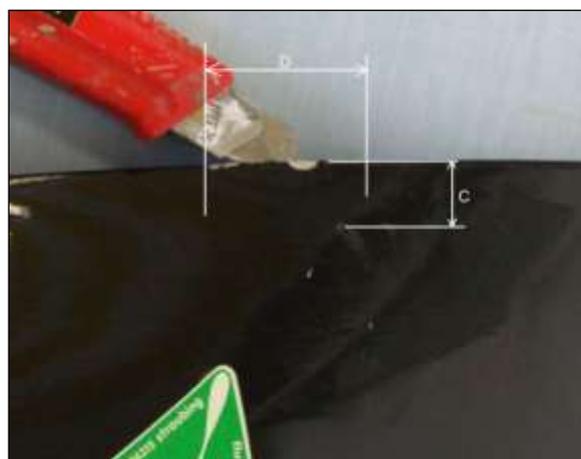
Delaminated fiber glass shell on the trailing edge may be rebonded if the debonding is not deeper (Dimension C) than 12.5 mm (0,5 in) measured from the trailing edge and not wider (Dimension D) than 25 mm (1 in).

Caution: **Assure that any moisture cannot enter the load carrying blade body.**

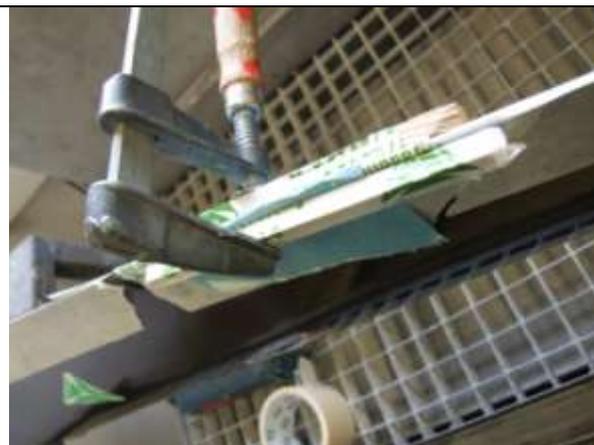
If the fiberglass shell on the trailing edge is delaminated the shell may be rebonded.
Let pour 5 minute Epoxy into the trailing edge crack.

Then clamp the trailing edge with C-clamps and let the epoxy cure.
Then clean the trailing edge and repaint the repaired area.

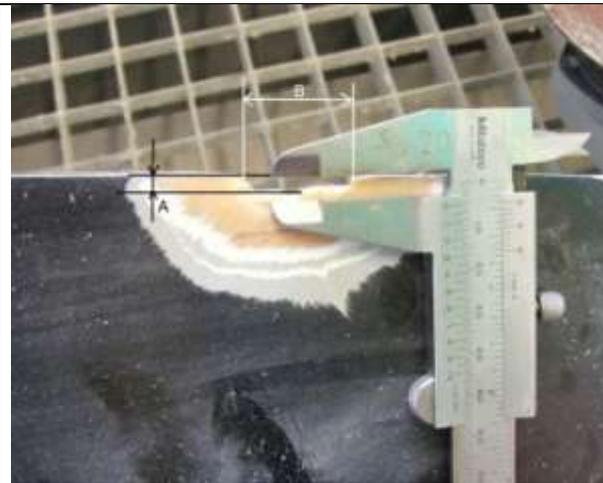
Measure the extent of damage
Max. 7,5 mm (0.3 in) from Trailing Edge and 25 mm (1.0 in) wide allowed for Field Repair.

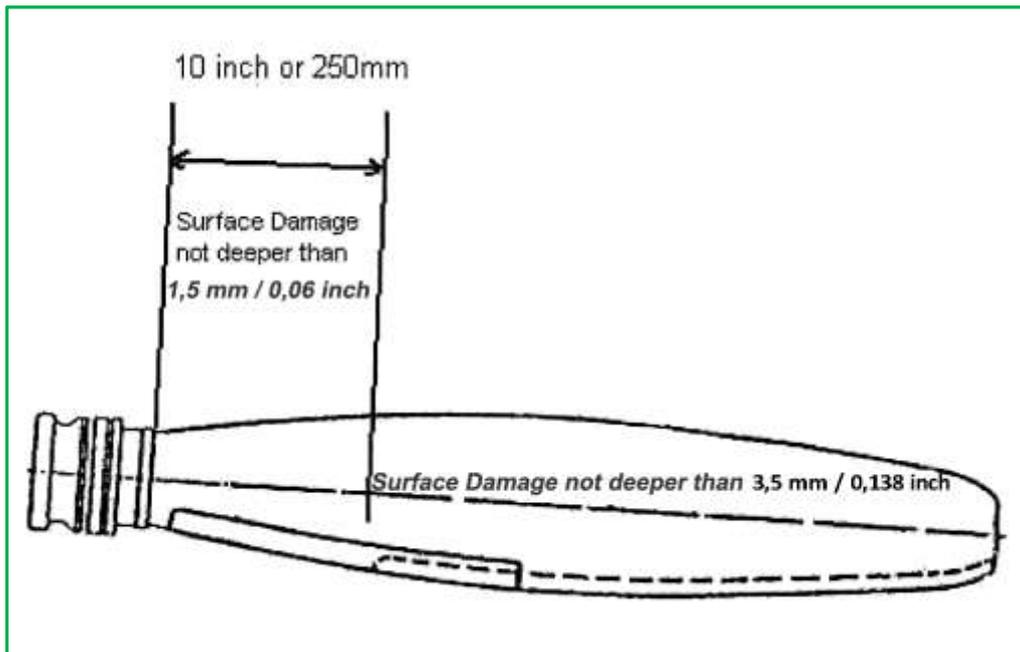
- ✓ There may be no crack in the load carrying natural composite structure beyond the following repair limits.
- ✓ All dimensions are measured after local removal of paint and filler.
- ✓ Blade Root: inside 250 mm (10.0 in) from Blade Ferrule: Damage may not be deeper than 1.5 mm (0.06 in.)
- ✓ Blade outside Blade Root: Damage may not be deeper than 3.5 mm (0.14 in).

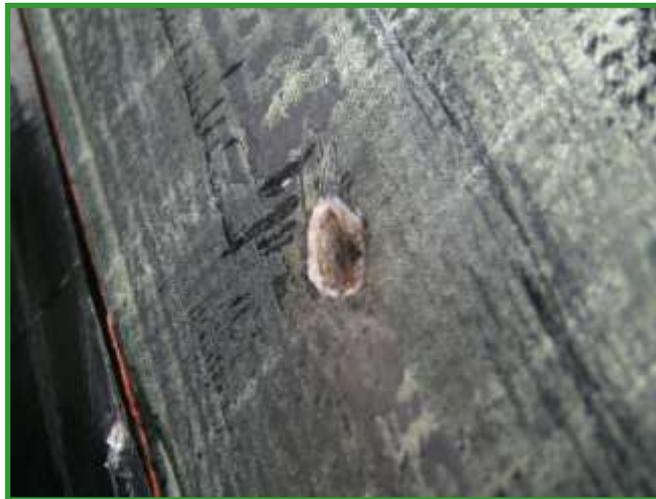
Maximum damage in the De-Ice Boot area:

14 mm x 8 mm x 1, 5 mm (0.55 in x 0.31 in x 0.06 in)

Surface damage whose size (E X E) is above 6mm x 6mm (0.2 in x 0.2 in) but below 12mm x 12mm (0.5 in x 0.5 in) must be field repaired by locally replacing the fiber glass shell.

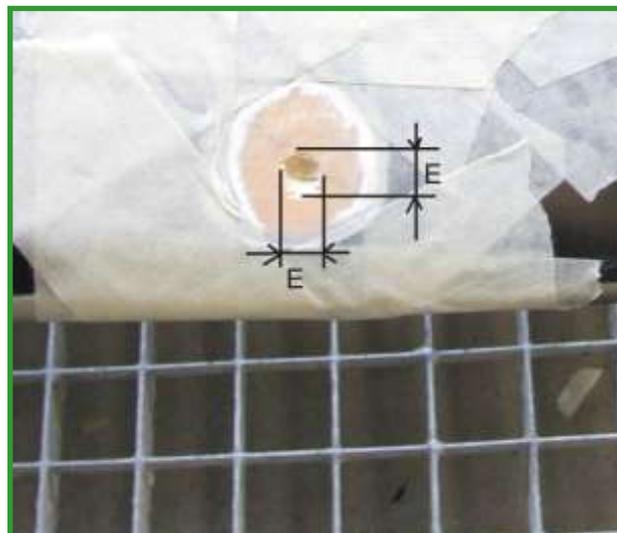
Blades with surface damage above 12 mm x 12 mm (0.5 in x 0.5 in) must be sent to the manufacturer or to an authorized service station for repair as soon as possible.

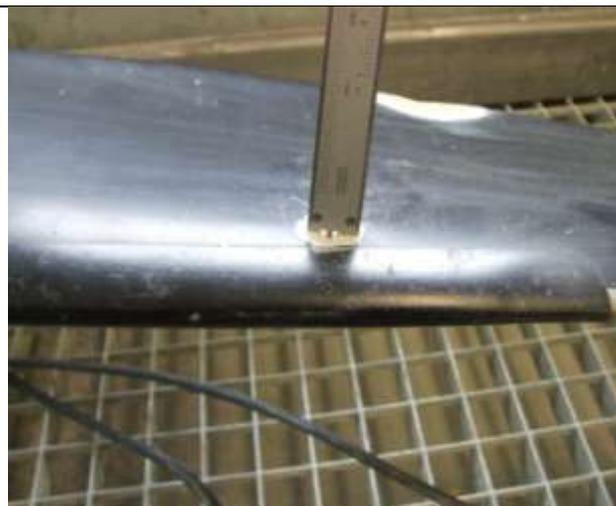
Field Repair Limits:
Blade Root: inside 250 mm (10.0 in) from Blade Ferrule:
Damage may not be deeper than 1.5 mm (0.06 in).
Blade outside Blade Root:
Damage may not be deeper than 3.5 mm (0.14 in)

Blade surface damage obviously exceeding the field repair limits

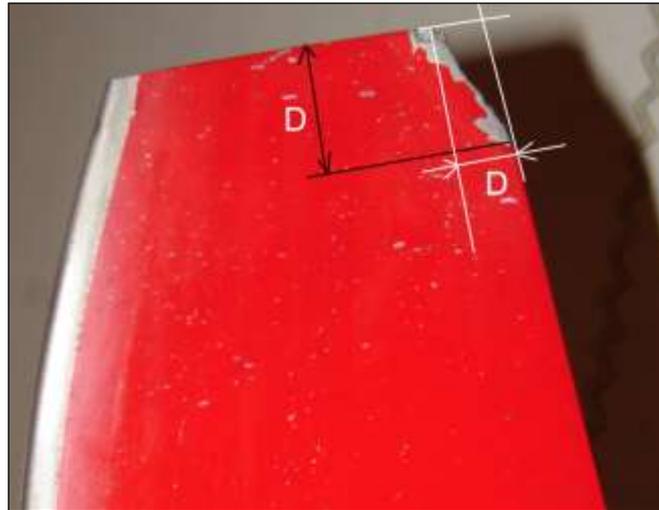
Broken blade tip Trailing edges

Maximum damage size measured from the blade tip trailing edge

Dimension "D" below 12 mm (0.5 in) : Only sealing with 5-Minute Epoxy required.
Dimension "D" above 12 mm (0.5 in) and below 25 mm (1.0 in) local repair with fiber glass required
